**CULTURAL RESOURCES INVESTIGATIONS
RELATING TO YUCCA AND AFRICAN HOUSES,
MELROSE PLANTATION (16NA591),
NATCHITOCHES PARISH, LOUISIANA**

Final Report

2014

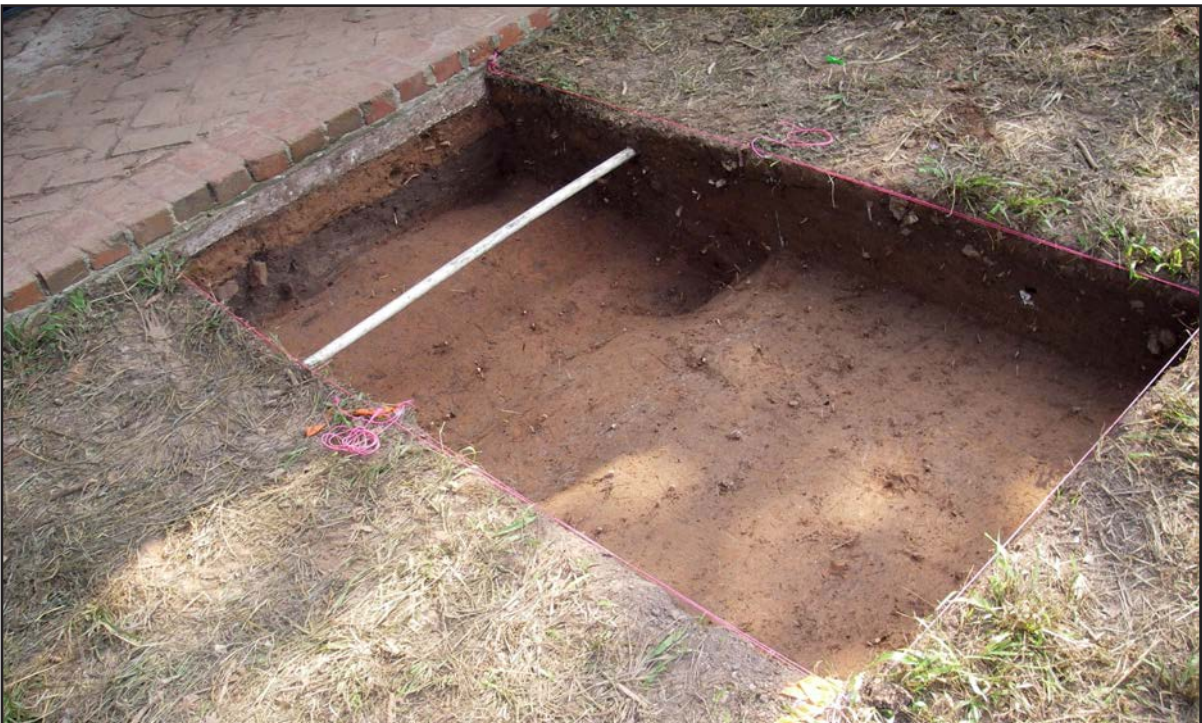
Figure 6.25. (Below) A photograph showing Units N5014-N5015 E4944 completely excavated. (View is to the southwest. September 7, 2006.)

The ashy character of the two central zones suggested these were a part of the feature previously encountered in Unit G. As such, these two were treated as a single entity and removed as one unit from both of the two excavation units (Figures 6.24-6.26). Feature 1 only extended down an additional 10 cm and appeared in profile as a shallow depression measuring 85 cm wide. It was linear in nature and corresponded to the outer roof line of Yucca house, suggesting it represented the drip line of the structure.

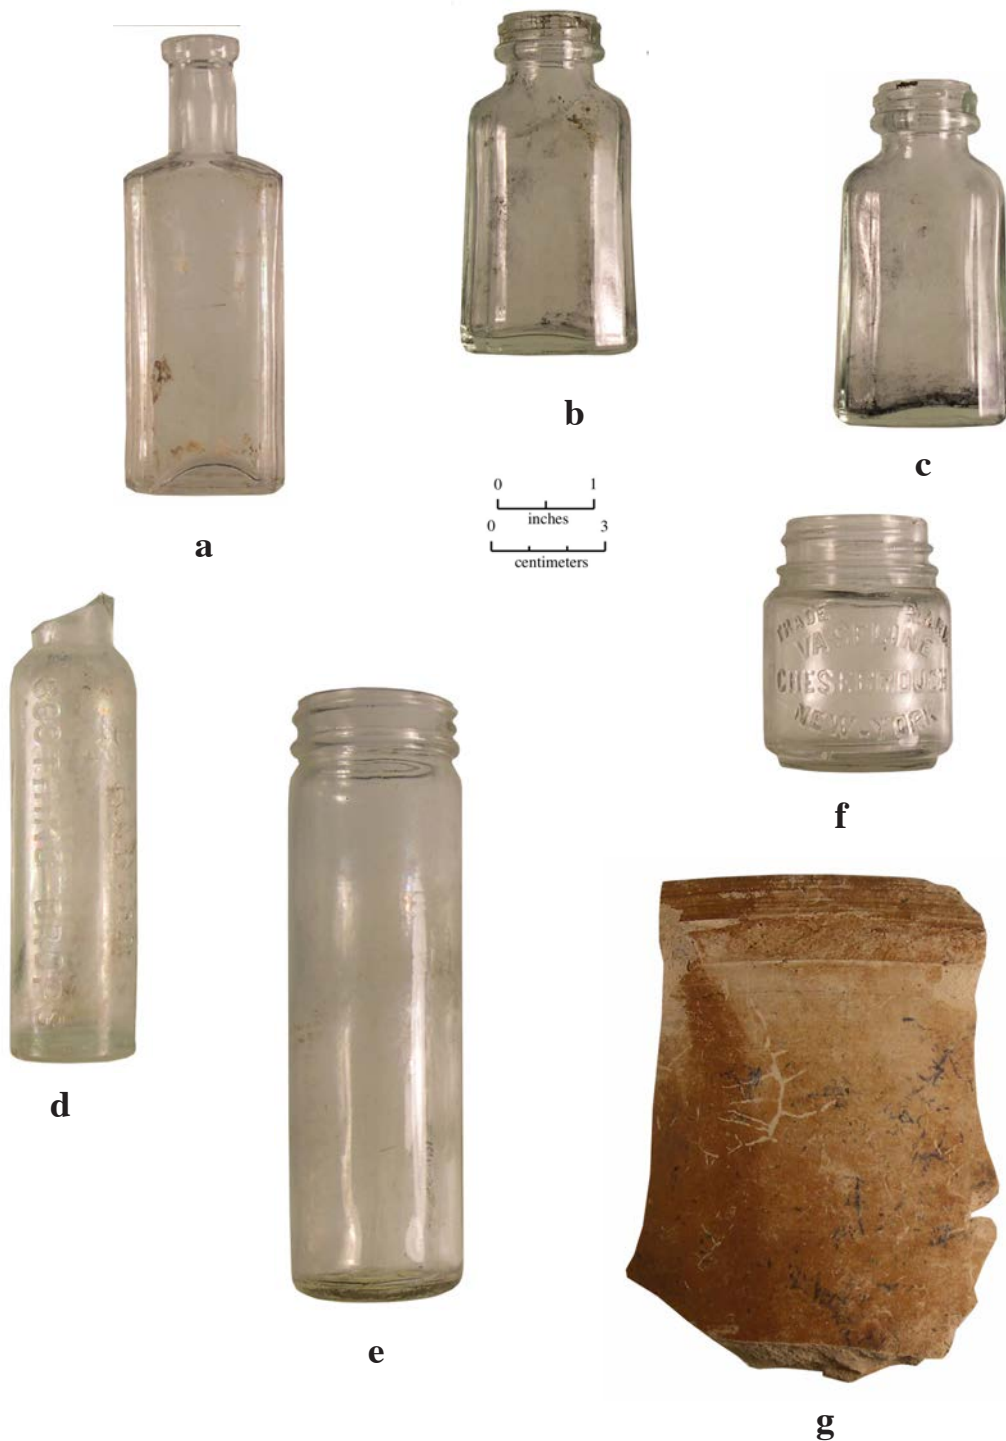
Figure 6.33. Selected artifacts recovered during construction monitoring around Yucca and African houses during the 2006-07 excavations at Melrose Plantation (16NA591): a, clear, machine-made panel bottle with Illinois Glass Co. mark; b-c, clear, machine-made 1 1/2-ounce shoe polish bottles; d, molded Dr. Harter's Soothing Drops medicine bottle; e, clear, machine-made olive/preserve bottle with Hazel-Atlas mark; g, unglazed, 11-inch-diameter stoneware jar fragment.

No archaeological features or deposits were observed during the dirt removal. However, a small collection of scattered artifacts was recovered from the stripped areas (Appendix E). The collection included several complete or nearly complete glass containers. One of those (Figure 6.33, d) was a partial clear glass medicine bottle. It measured 1 1/4 inches in diameter. It lacked most of its neck and all of the lip; however, it was greater than 4 1/2 inches tall. Embossed on its side was "DR. HARTER'S SOOTHING DROPS." The product was produced

ca. 1873-1916 (Fike 1987:165) and was commonly used to treat colic and for teething infants (Cannon, n.d.).
